“ADDENDUM” TO ORIGINAL REPORT FROM FEBRUARY 21, 2013

**VILLAGE OF ANMORE
2697 SUNNYSIDE ROAD
ANMORE, B.C.**

**BY
LLOYD E. LUCAS, ASCT, CPI
PROJECT BUILDING INSPECTOR**

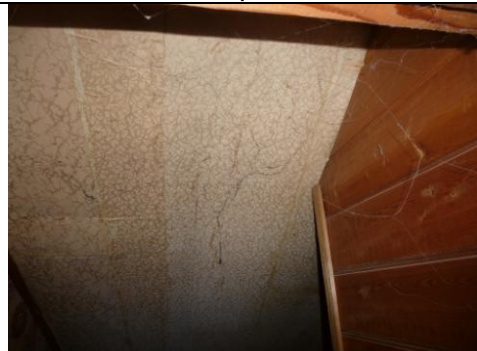
Attic Insulation – the present attic insulation levels are estimated at R-05 to R-07.

The recommended effective levels for energy efficiency are R-30 to R-40.

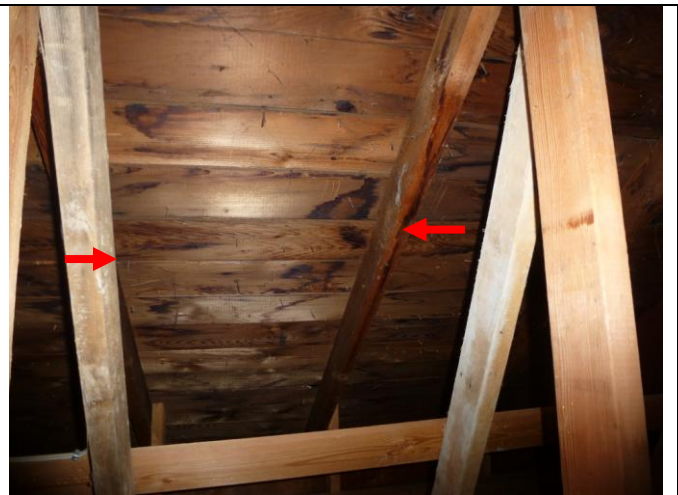
Attic Insulation – the present attic insulation levels at some locations are estimated at R-0

The recommended effective levels for energy efficiency are R-30 to R-40.

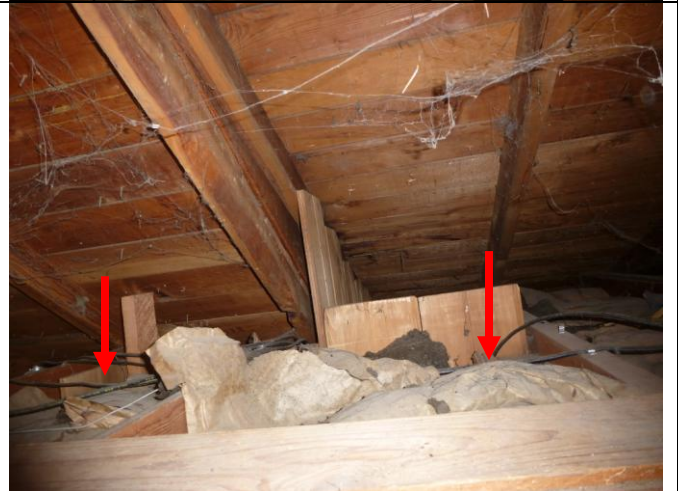
Attic Insulation – the present attic insulation levels at some locations are estimated at R-0 to R-05

The recommended effective levels for energy efficiency are R-30 to R-40.
